# Seismic Risk Evaluation of Community Mosques in Southern Malang to Assess Their Suitability to Support Disaster Response

**Keywords:** Community mosque, disaster response, earthquake, rapid evaluation, seismic risk

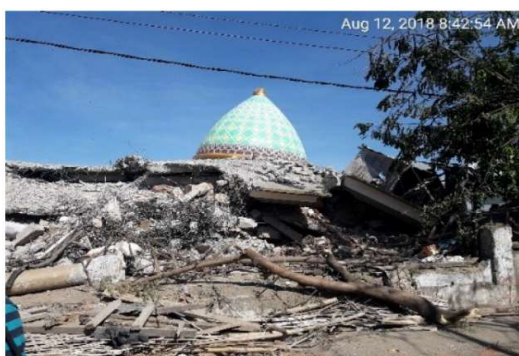
**Figure 1** A mosque with severe damage after an earthquake in Lombok, August 2018 [3]

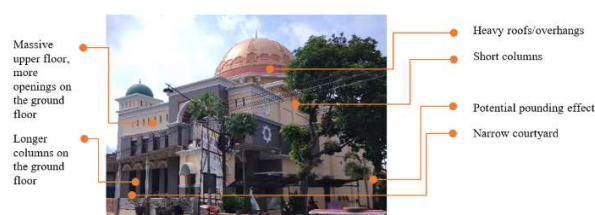
The structural aspects analyzed in this study are (1) potential soft-story, (2) the presence of short columns, (3) the presence of slender columns, (4) the presence of heavy roofs/overhangs, (5) potential pounding effect, (6) the absence/presence of seismic force resisting systems (shear wall, braced frames, or moment frames), and (7) potential topographic effect. Figure 4 is an example of the seismic risk visual screening on one of the studied mosques.

**Figure 4** The seismic risk visual screening of a mosque

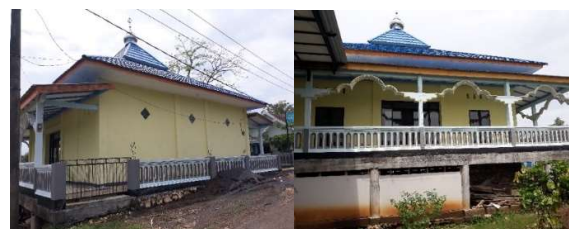
The seventh aspect is the possibility of a potential topographic effect on mosque buildings. A mosque building located on a sloping site has the potential for topographic effect during an earthquake, especially those with a steep slope. 36% of the studied mosques were built on the sloping sites. However, the possibility of a topographic effect during earthquake in several mosques may have been reduced by the presence of retaining walls and efforts to flatten the surface of the sites. Further examination is needed on the quality of the retaining walls, so during an earthquake the retaining walls are strong enough to hold the buildings above.

**Figure 11** An example of mosque built on a sloping site with some short columns and discontinuous columns

4. Inconsistencies or irregularities in moment frames that occur frequently need to be improved by adding side columns and/or mid-height beams, or by modifying the existing structural elements to strengthen the whole structure.
